# Manhole Inspection Summary

Manhole # S13GG2017MH

Insp Date: **6/29/06 9:32 AM**

**Location** Address: **5905 EASTCLIFF DR**

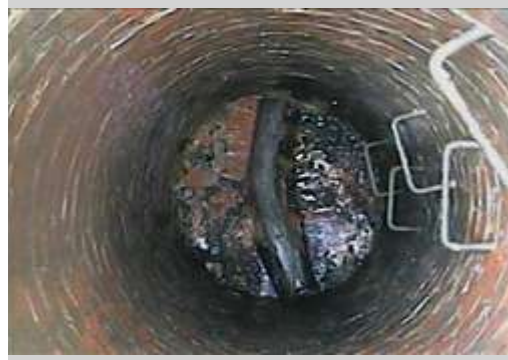
Top View

Infiltration: ☐ None ☒ Joint ☐ Cracks ☒ Mortar ☐ Roots ☒ Wall

Condition: ☐ Sound ☐ Cracked ☐ Root Intrusion ☐ Deteriorated ☐ Leaks ☒ Debris

**Surcharge** ☒ Evidence Of Surcharge Depth: **2** (ft.) ☐ Active Surcharge Present

Corbel and Barrel infiltration. Evidence of surcharge - Bench debris.

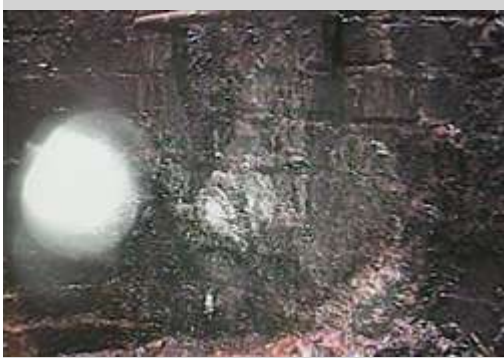
Defect

Infiltration: ☐ None ☐ Joint ☐ Cracks ☒ Mortar ☐ Roots ☒ Wall

Barrel infiltration.

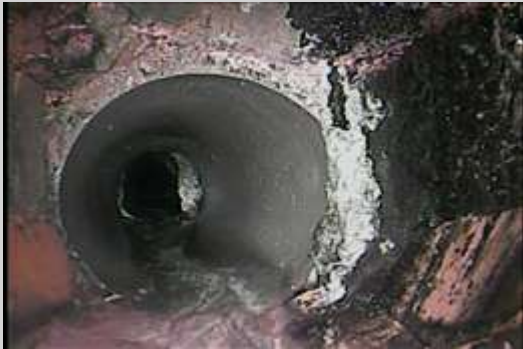
### 8 in. Circular Gravity Sewer Pipe Out @ 12 O'Clock

Grease deposits.

Deposits: ☐ None ☐ Mud ☐ Sludge ☐ Debris ☒ **Grease**

Silt Depth: **0** (in.) Deposits Extent: **Light**

Infiltration: **None** Pipe Seal Cond: **Cracked**

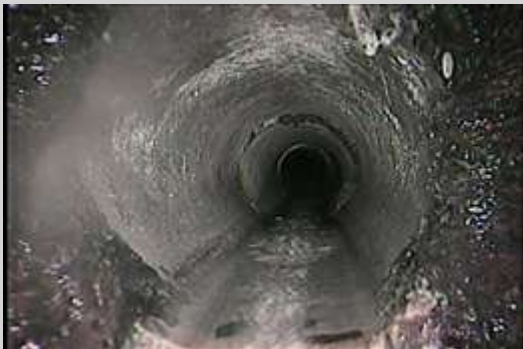
### 8 in. Circular Gravity Sewer Pipe In @ 6 O'Clock

Deposits: ☐ None ☐ Mud ☐ Sludge ☐ Debris ☒ **Grease**

Silt Depth: **0** (in.) Deposits Extent: **Light**
